Maine Forestry Best Management Practices Use and Effectiveness, 2008

Maine Forest Service

August 2009

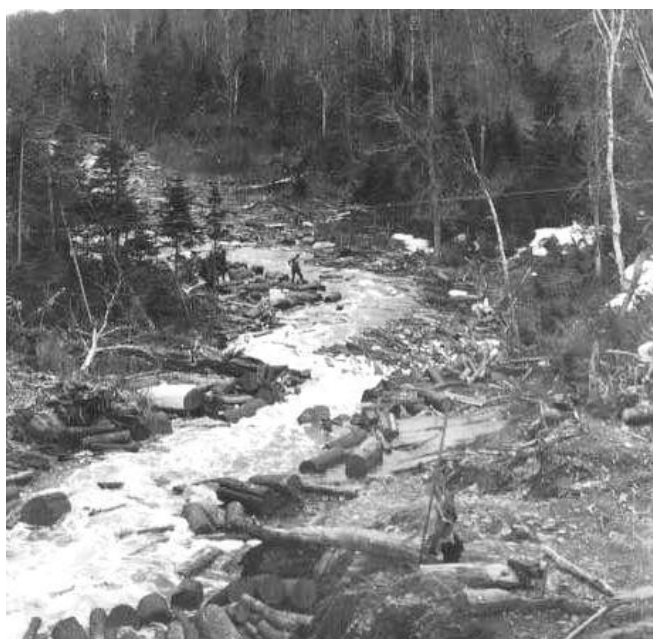
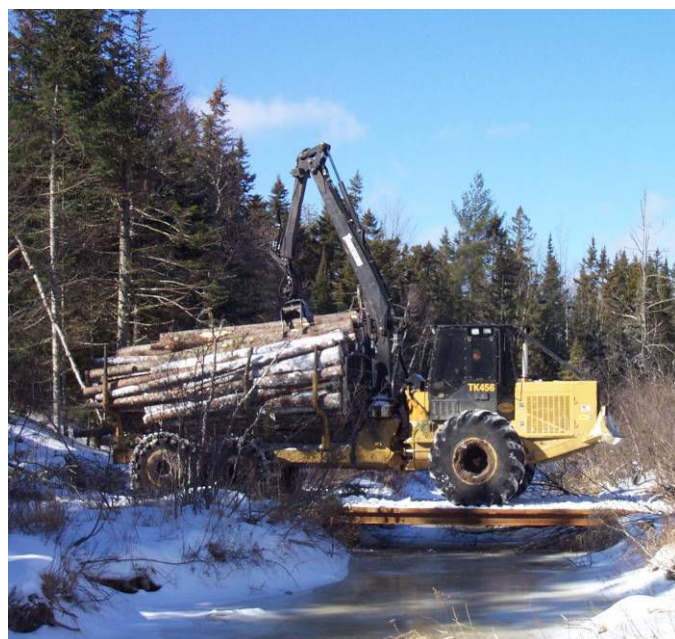
Then and now. As recently as the 1970’s little consideration was given to protecting water quality on timber harvests as the highly eroded banks in the log drive photo on the left illustrates. In contrast, today there is a general acceptance of BMPs by the forestry and logging professions. Sights like forwarders being used to minimize ground disturbance and temporary bridges to protect the integrity of stream channels indicate how far BMPs have come.

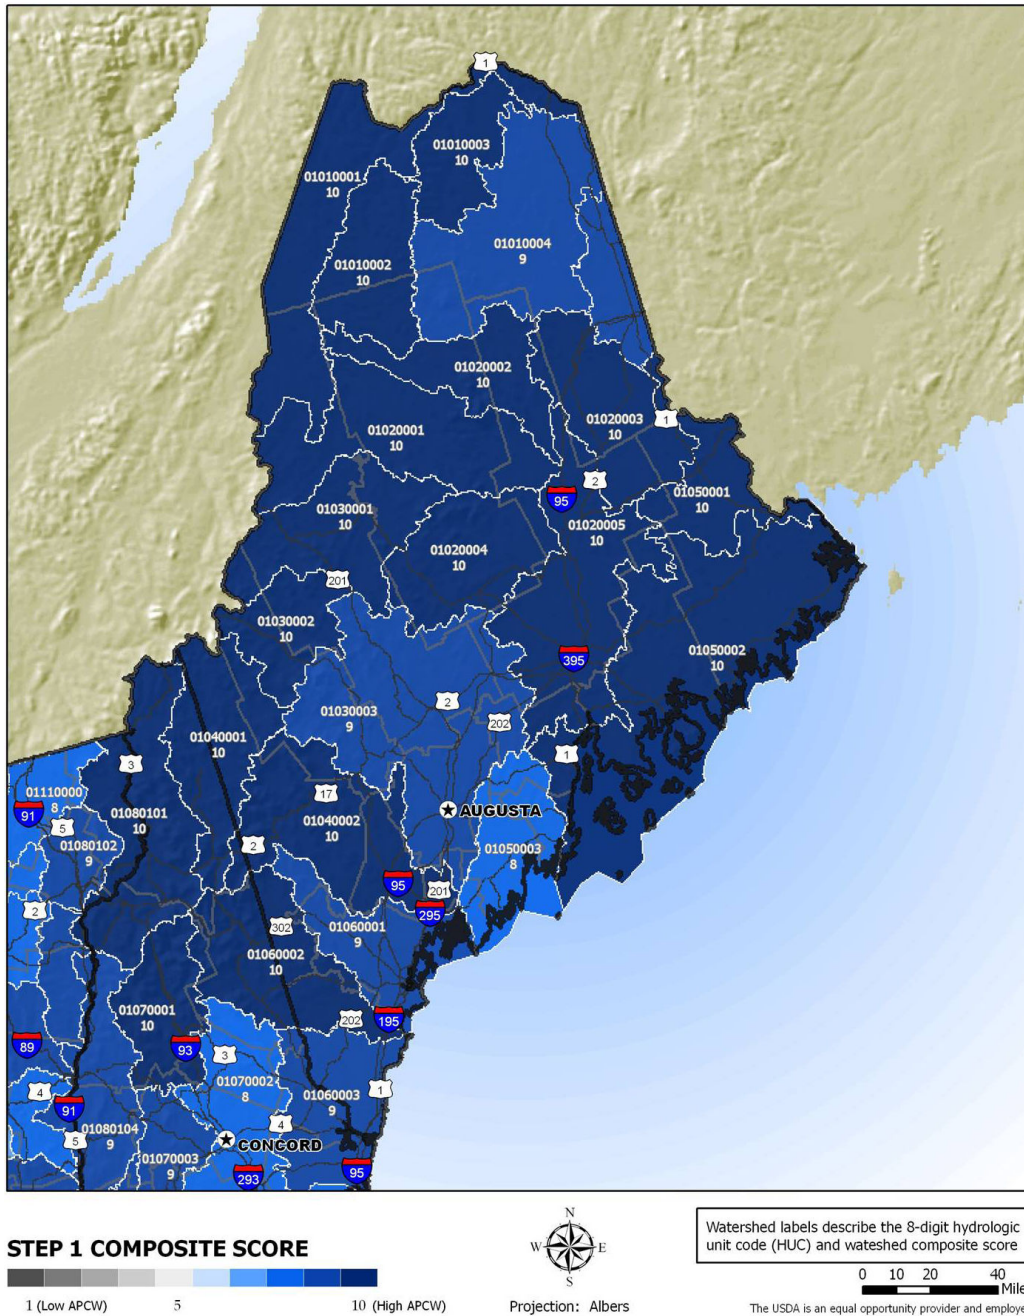
USDA Forest Service Analysis showing the ability of Maine's watersheds to produce clean drinking water. Darker colors indicate greater ability to produce clean water. The same forests that produce this clean water also support a harvest of approximately 6,000,000 cords of wood annually.

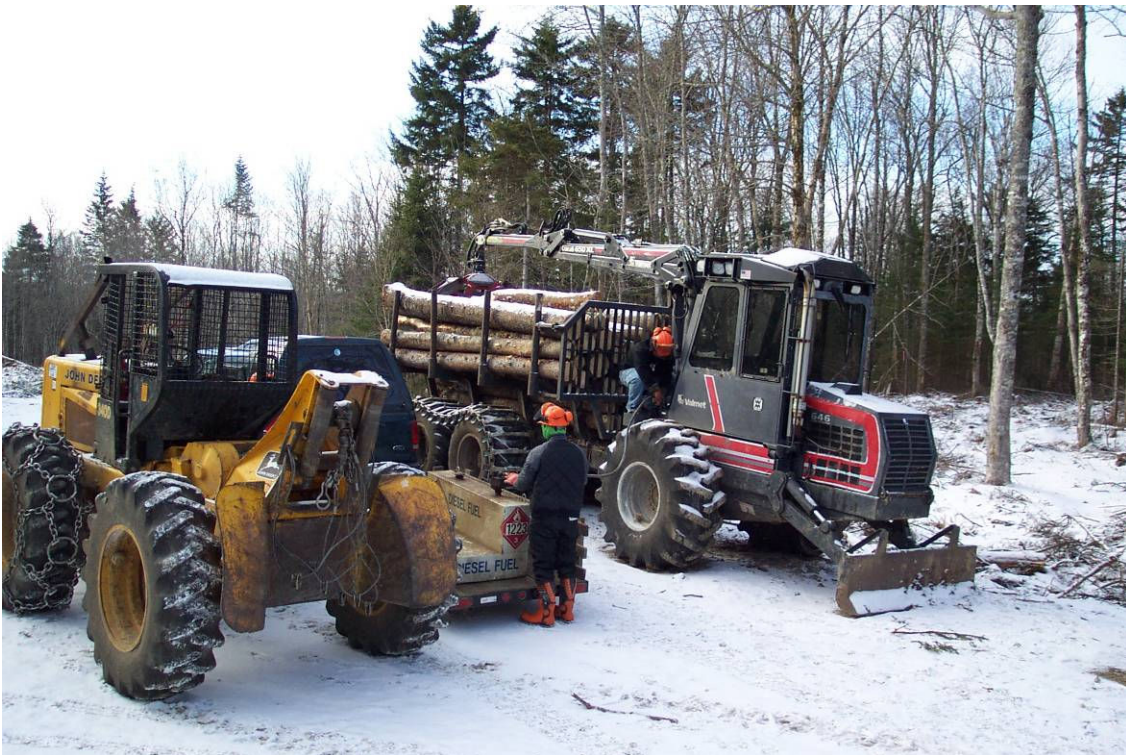
When used properly carried wood systems (e.g. the forwarder seen on the right) can result in less soil disturbance vs. dragged wood systems (e.g. the cable skidder seen on the left). Regardless of the type of system used, operator skill and training are critical to good results.

MFS encourages operators to upgrade to carried wood systems by offering low interest loans through its Direct Link Loan program. This program, backed by the Maine Municipal Bond Bank, offers loans at reduced interest rates to logging contractors who purchase or upgrade equipment designed to minimize soil disturbance associated with timber harvesting.

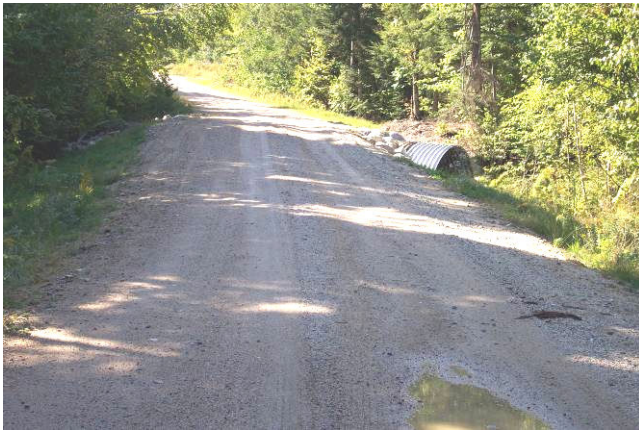
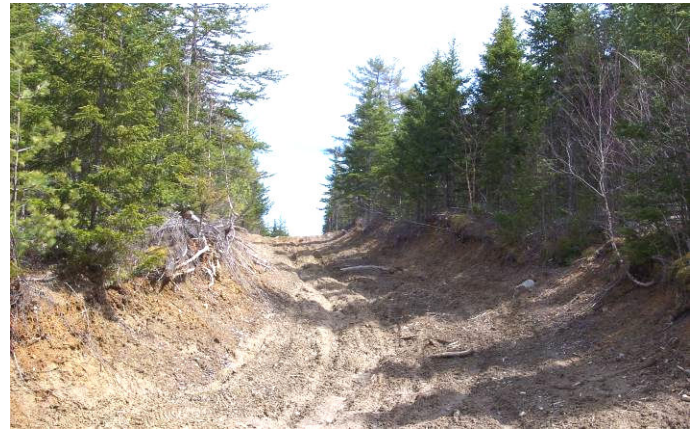
BMPs should extend uphill from the crossing to the point at which a break in the road grade directs water away from the crossing. The road on the left has well designed approaches that direct water into a vegetated filter strip before it reaches the stream. In contrast the road on the right has no place for the water to go before reaching the waterbody. Grading to maintain the road crown, ditch turnouts and vegetated filter strips are some of the BMPs used on approaches.

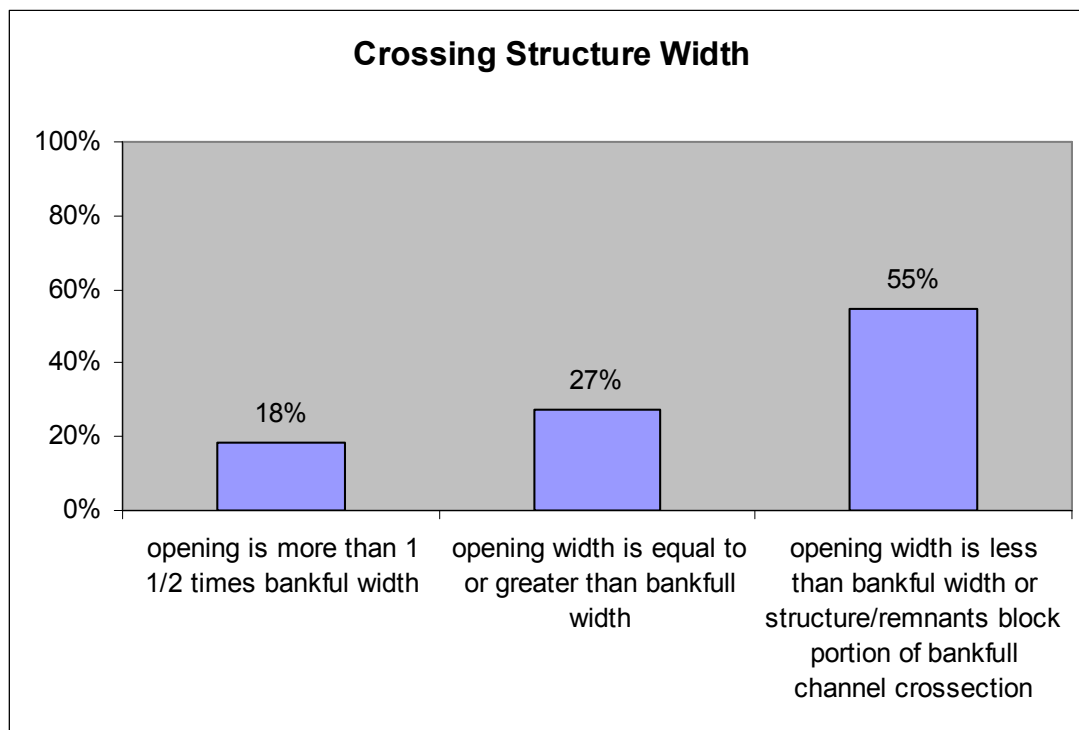
Figure 15 Width of crossing structure in relation to waterbody width at pre structure bankfull elevation. (n=68)

In Maine legal requirements for structure opening size vary depending on the jurisdiction. However, properly sized structures typically should also be *at least* equal to the bankfull width of the channel. Maine Forest Service BMPs

recommend that temporary crossings and permanent structures that will be regularly maintained be sized to accommodate a 10 year flood event (2.5 times the cross sectional area of the stream channel at bankfull). BMPs recommend permanent crossings that will not be regularly maintained be sized to accommodate a 25 year flood event (3.5 times cross sectional area). Undersized crossings can lead to conditions that limit fish passage including increased flow velocities, perched outlets and accumulated debris barriers. Undersized structures are also at increased risk of being unable to handle high water flows and therefore are more likely to experience catastrophic failures leading to large sediment inputs. *55% of the crossings evaluated did not span the bankfull width of the channel.* This is an 11% decrease from the 2006-2007 level of 66%. Additional years of data will be required to see if the improvement in the numbers of crossings that span the stream channel represents a trend (Figure 15).

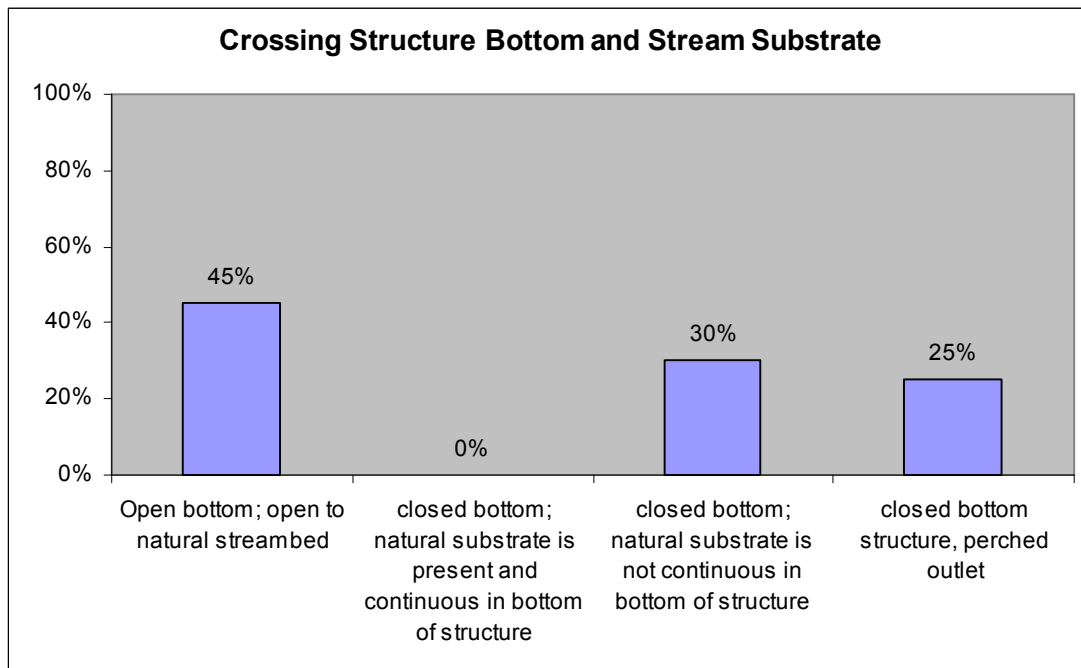
Figure 16 Presence of substrate in crossing structures. (n=40)

Crossing structures properly designed and installed to allow fish passage incorporate either natural or simulated natural stream bed substrate in the bottom of the structure. Open bottom structures such as bridges and arch culverts allow natural stream bed substrate to be maintained. Closed bottom structures such as round culverts, box culverts and pipe arches can also incorporate substrate by being embedded in the stream bottom or being sized large enough to allow bed load substrate to accumulate in their bottoms over time. **45%** of the crossing structures were open to the natural stream bed. *No closed bottom structures had*

continuous substrate in the structure bottom. **25%** of closed bottom structures had perched outlets. Perched outlets can be severe impediments to fish passage (Figure 16). Perched outlets can result from improper initial installation and/or undersized structures. Undersized structures accelerate flows which leads to down stream scouring, which in turn lowers the elevation of the downstream streambed. This can result in a culvert that was formerly at grade becoming perched. The Maine Forest Service, in cooperation with many partners, has conducted numerous training efforts for operators and foresters on proper installation techniques for fish friendly crossings.

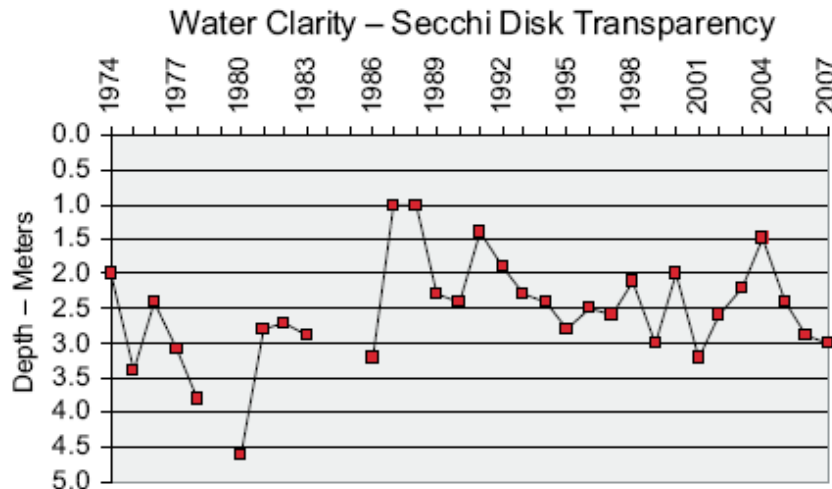
Water clarity in Madawaska Lake abruptly declined in 1987. From 1987 to 1992 the lake suffered four nuisance algae blooms (SDT < 2.0 meters). Since 1993 water clarity has improved, and the lake has been free of algae blooms for 14 of the past 15 years. (Note: no data were collected in 1979, 1984 and 1985.)

Located in Aroostook County, Madawaska Lake experienced declining water quality beginning in the 1980s when increased timber harvesting, road building and shoreland development in the watershed contributed excess phosphorus and sediment to the lake. As a result, Maine Department of Environmental Protection (MDEP) added Madawaska Lake to the state's 1988 Clean Water Act section 303(d) list of impaired waters. The lake's water quality began improving in the mid-1990s, due to changes in statewide forestry standards, improved regulatory oversight of development and the implementation of forestry BMPs. MDEP removed Madawaska Lake from its section 303(d) impaired waters list in 2006.⁵

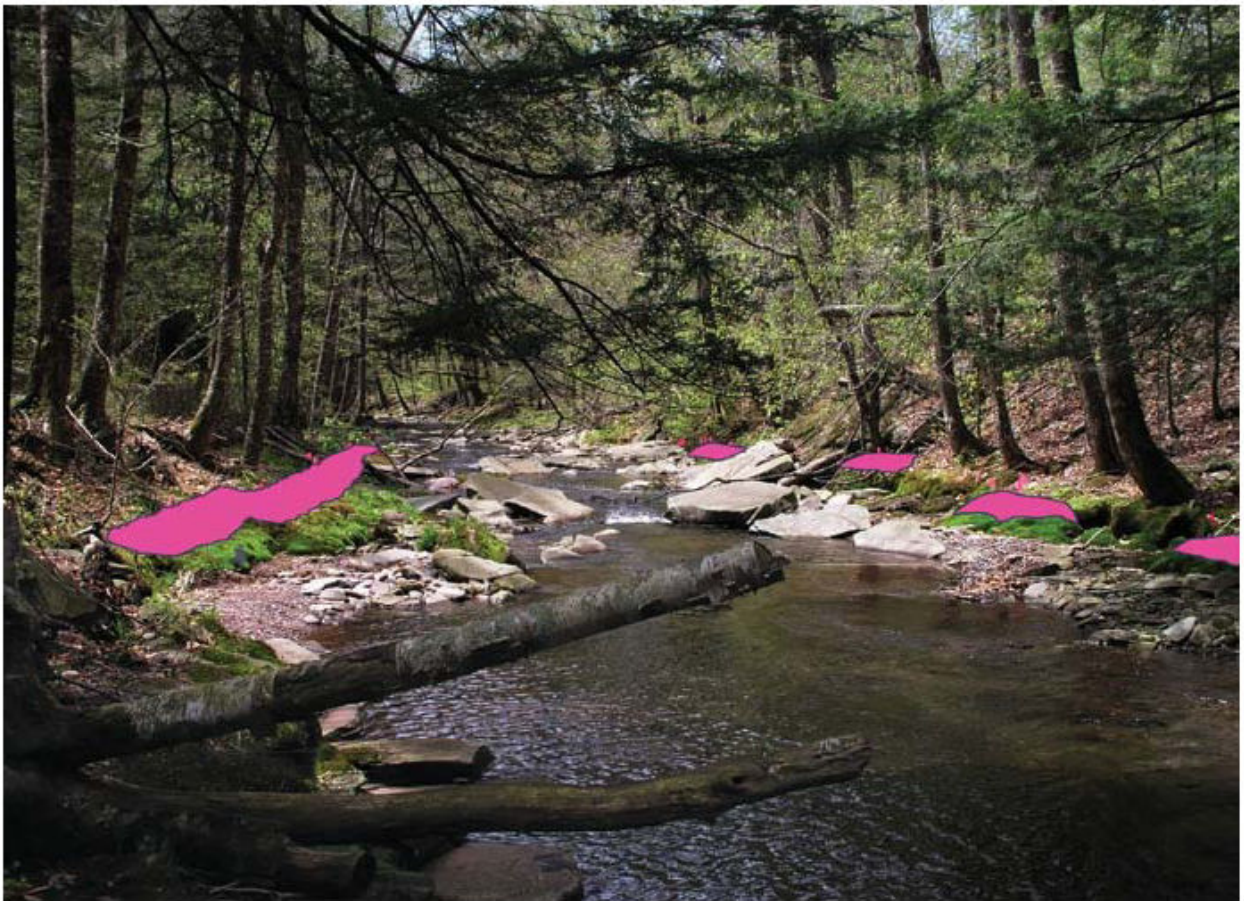
Figure 19 Bankfull indicators visible at low flow. The bankfull elevation is indicated by the first depositional flat above the channel. On very confined channels, the bankfull elevation may only be evident as the discontinuous flat depositional areas shaded on the photo.

Bankfull width is the channel width from the bankfull elevation on the one side of the channel to the bankfull elevation on the other side of the channel.
